Failure Analysis and Field Repair of Urea reactor

The outer shell of a Multi-layered Urea reactor ruptured while the plant was in operation. The plant made an emergency shutdown, samples were collected, and an investigation carried out to establish the root cause of the failure. The paper explains the detailed analysis performed, corrective action implemented, and a health assessment for the equipment's safe working. The paper also includes references to similar failures in old multi-layered urea reactors subsequently and the mitigation plans to avoid such failures.

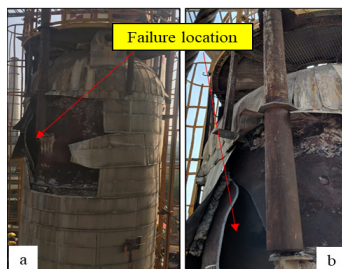
The urea reactor is a critical component in any fertilizer plant. Urea is formed in the urea reactor by the ammonia and carbon dioxide reaction at elevated pressure and temperature. During normal operation of the urea plant, a sudden sound and a rupture were found in the outer shell layer of the urea reactor. Figure 1 shows the rupture of the outer shell, with a tearing of 1.5 m (4.9 ft) length. This multi-layer Urea reactor was supplied in 1982 and has been in operation for more than 35 years, with regular maintenance work carried out every 2 to 3 years, which included inner liner inspections and repairs.

Figure 1: Tearing of urea reactor outer shell

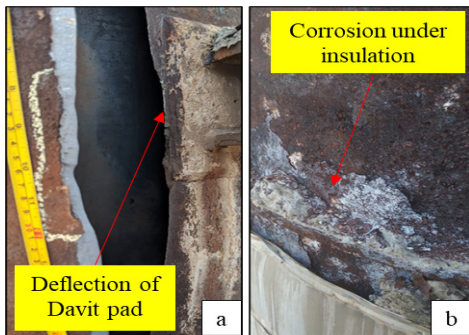
Visual inspection of the Urea reactor showed tearing of the outer shell layer resulting in a 1.5 m (4.9 ft) wide opening near the davit arm location, as shown in Figure 3a. Deflection of the davit arm and bulging near the ruptured zone were observed.

Heavy scale formation was observed on the outer shell as shown in Figure 3b. Thickness of the shell layer was reduced (~13.5 mm (0.53 in) against original 14.9 mm (0.59 in)), due to corrosion under insulation.

Figure 3: Tearing of outer shell and scale formation beneath insulation

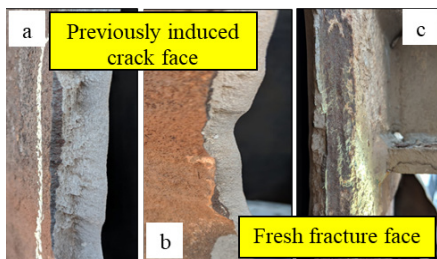
The fracture surface is shown in Figure 4, which shows pre-existing crack face and fresh rupture face. This pre-existing crack seems to have initiated near the edge of fillet weld between the manway davit arm pad plate and the outer shell layer.

Figure 4: Fracture surface on (a-b) Shell layer side (c) Davit arm pad side

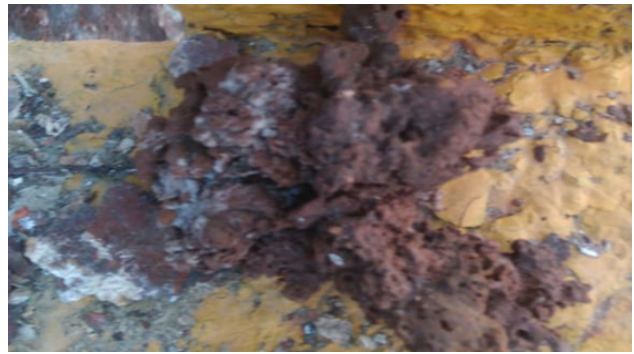
Figure 5: Deposit collected from weep hole

An air test was performed to find the leakage in the liner at the top portion of reactor (Top head + Shell). The test was not successful due to weep holes blockage. Further steam purging was carried out to clear the weep holes. Deposits were observed at the weep hole opening and collected for analysis (Figure 5).

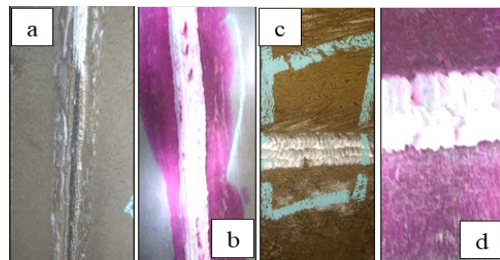
Visual inspection and dye penetrant test (DPT) of the inside liner surface showed signs of corrosion on the longitudinal and circumferential weld joints, as shown in Figure 6. Corrosion was also observed on the weld built-up area buttering (old cleat removal area). Localized dents and bulges on liner surface were also observed.

Figure 6: Corrosion on liner Longitudinal seam (a-b) Circumferential seam (c-d)

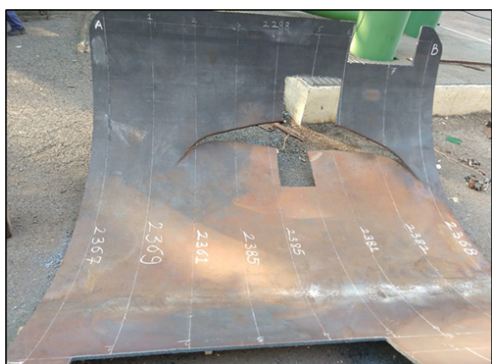
After cutting and removal of the outer shell layer, the inside surface of the layer revealed discoloration towards weep hole-W9, as shown in Figure 7.

Figure 7: Inside surface of outer shell layer

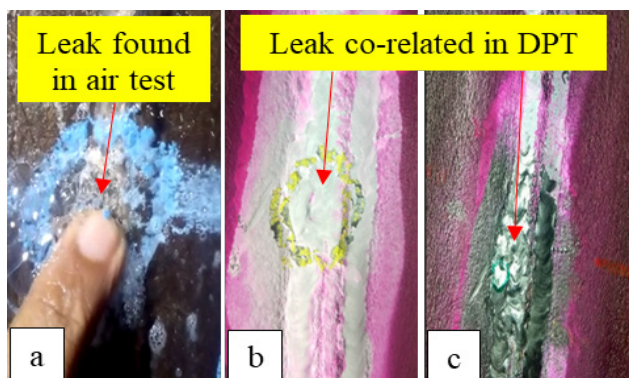
Air testing was conducted after the blockage in weep holes was removed. This revealed leakage in the liner long seam, in the area between the 1st and 2nd trays, as shown in Figure 8a. The leakage location was then verified by dye penetrant test (Figure 8b and 8c).

Figure 8: Leak found in air test and veri-fied in DPT

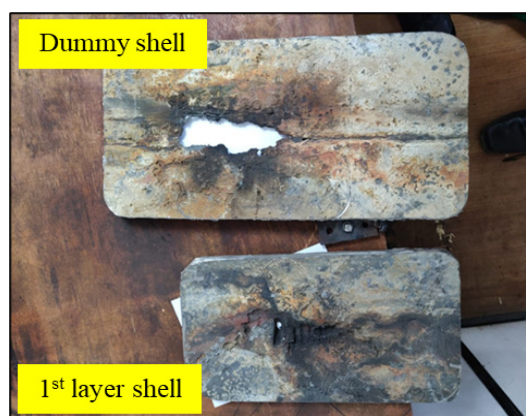
After cutting the liner plate at the leakage location, the inner dummy shell and 1st layer shell were corroded through as shown in Figure 9.

Figure 9: Corrosion of dummy shell and 1st shell layer due to liner leakage

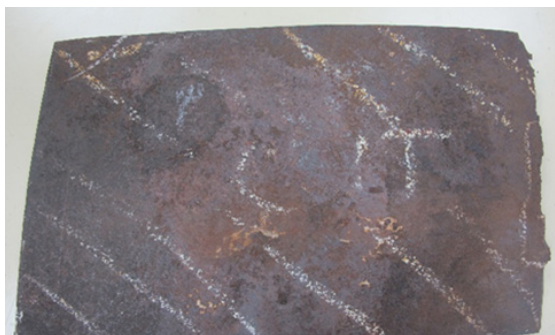
The outside surface of the shell layer showed the presence of heavy scaling, as shown in Figure 10.

Figure 10: Corrosion under insulation on outside surface

- During a visual inspection at site, heavy scaling due to corrosion was observed on the outside surface of the outer shell layer. Thickness of the shell was found to be reduced by 1.5 mm (0.06 in) due to scaling. EDS of the scale formed on the outer layer under insulation was found to be mainly oxygen and iron. This indicated moisture and general corrosion under insulation on outer shell layer over the time.

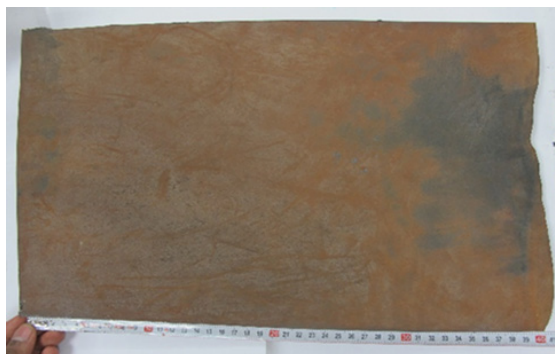
The inside surface shell layer revealed discoloration as shown in Figure 11. The residue was analyzed to be iron and oxygen.

Figure 11: Brownish discoloration on inside surface

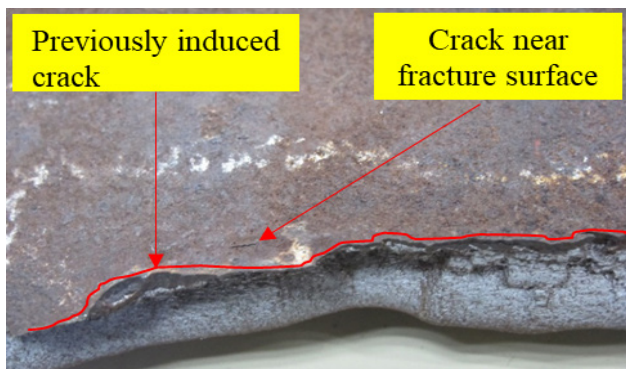
A pre-existing crack (~3 mm (0.12 in) depth) was observed on the fracture face, and shown in Figures 12 and 13. This pre-existing crack appears to have initiated near the edge of the fillet weld between the manway davit arm bracket pad plate and the outer shell layer, as shown in Figure 14.

Figure 12: Failure location - Crack near fracture surface

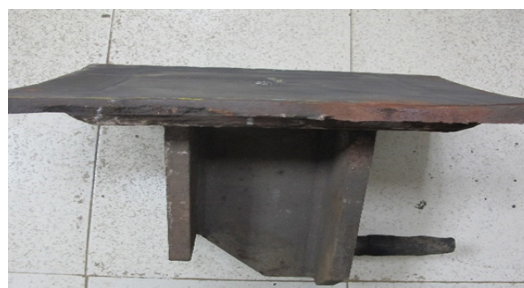
Figure 13: Failure location - fracture surface pad plate side

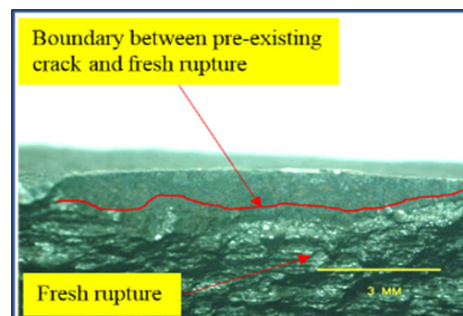
Figure 14: Macro examination previously induced crack and fresh rupture – 10X

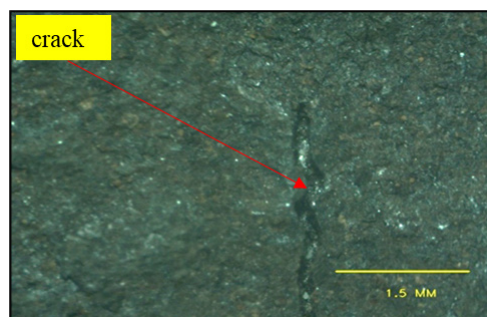
Additionally, a small crack was observed near the fracture surface, which appeared to be generated due to mechanical force during fracture of shell layer (Figure 15).

Figure 15: Crack beside fracture surface - 20X

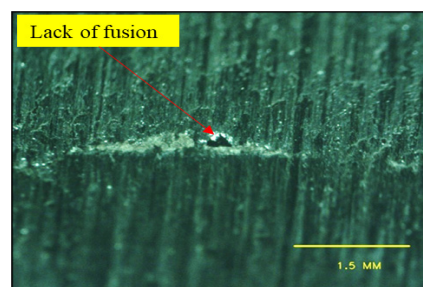
After visual and macro examination of the extracted samples, specimens containing the failure locations were cut for subsequent analysis. Specimen containing the fillet weld (Pad plate to outer shell layer weld) showed a lack of fusion with shell layer (Figure 16).

Figure 16: Discontinuity in fillet weld between pad plate to shell layer - 20X

- The lack of fusion in the davit pad to outer shell layer fillet weld was observed in visual examination and SEM of the specimen containing the fracture surface. The presence of such a discontinuity at the edge of the weld increases the possibility of crack initiation and propagation over a period of time.

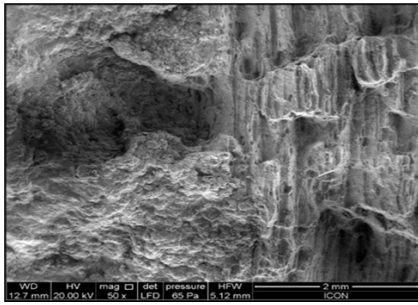
SEM of shell layer side part of the fracture surface clearly revealed a boundary between pre-existing crack and fresh rupture, as shown in Figure 17. The maximum depth of the crack was found to be ~3.7 mm (0.15 in).

Figure 17: SEM Image for boundary between previously induced crack and fresh rupture

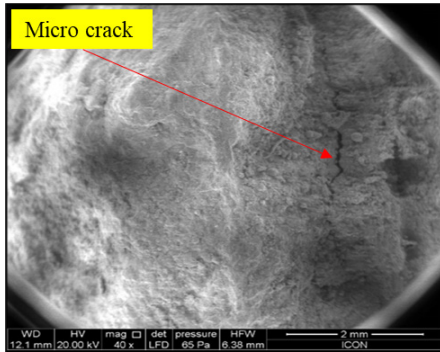
A specimen containing the pad side part of the fracture surface that showed lack of fusion in the weld revealed a micro crack in the base metal adjacent to weld edge, as indicated in Figure 18. The edge of the weld was revealed,

Figure 18: SEM Image for crack on fracture face near weld

which appeared to be the initiation point of the pre-existing crack.

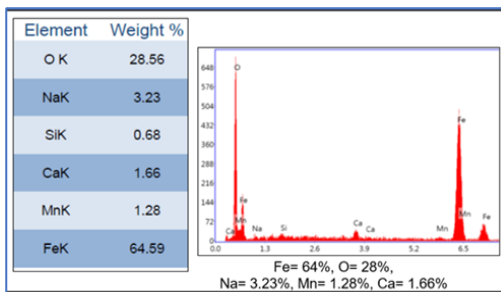
Figure 19: EDS on previously induced crack face

EDS revealed a significant amount of oxygen, iron, and other elements like sodium, calcium, and manganese on the pre-existing crack face and at the crack beside the fracture surface (Figures 19 and 20).

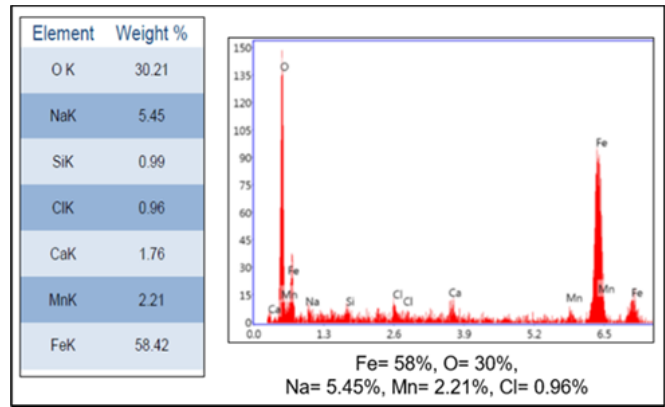
Figure 20: EDS on crack beside fracture surface

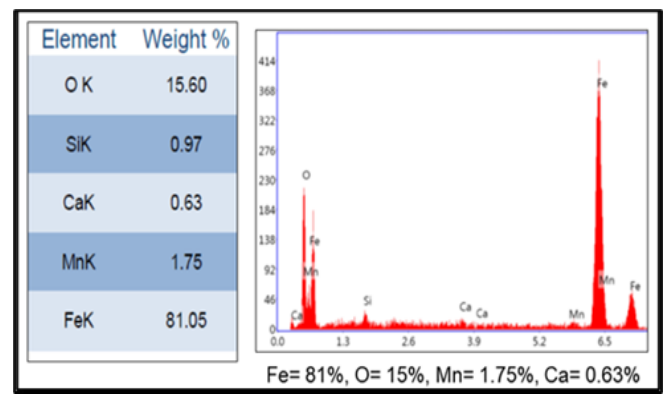
A significant presence of oxygen and iron, along with elements like sodium, manganese, calcium, and chlorine was observed on the crack face near the outside surface of shell layer. (Figure 21) A lower amount of oxygen was noticed on the rupture face as compared to the pre-existing crack face. This indicated low degree of oxidation on fresh rupture face.

Figure 21: EDS on rupture face

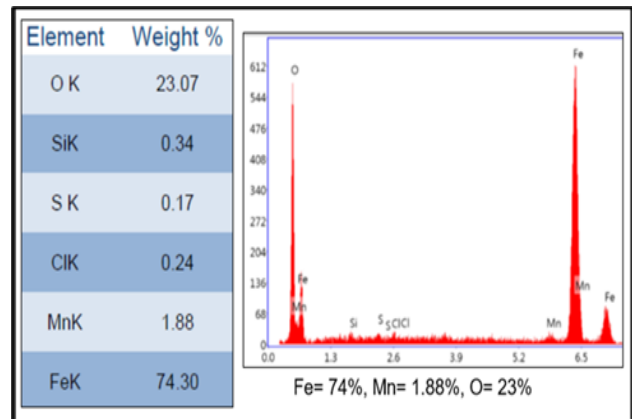
Scale formed on the outer layer of the shell consisted mainly of iron and oxygen. (Figure 22)
The deposit collected from the weep hole showed significant presence of nitrogen, oxygen, and carbon (Figure 23).

Figure 22: EDS of scale formed on shell layer

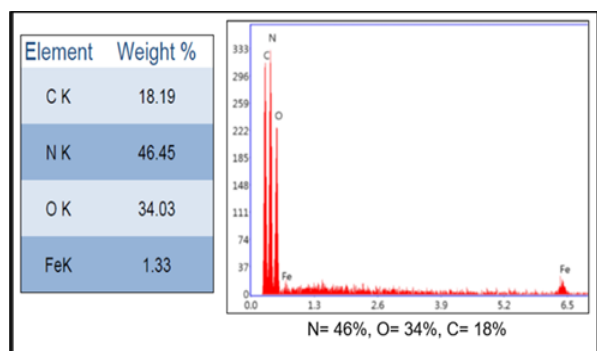
Figure 23: EDS of deposit collected from weep hole

- EDS testing of the deposit collected from the weep hole showed significant nitrogen, oxygen, and carbon presence. This showed carbamate leaked through liner was solidified and deposited at the weep holes. The inside surface of the extracted outer shell layer revealed discoloration towards weep hole-W9 side, which was likely the path of flowing media generated due to weep hole blockages.

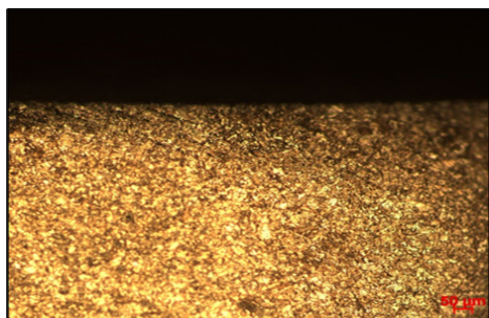
Microstructure of shell layer showed tempered martensitic structure (Figure 24).

Figure 24: Microstructure near shell layer from outside - 50X

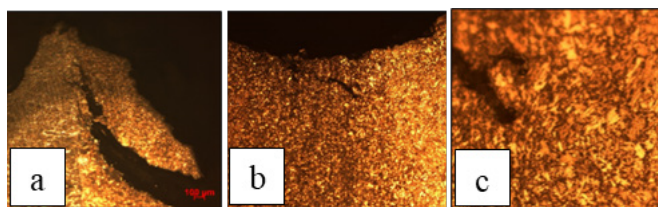
The pre-existing crack appears to be initiated from edge of the fillet weld and propagated in heat affected zone (HAZ) in the outer shell layer. (Figure 25)

Figure 25: (a) Crack initiation point - 50X, (b-c) Crack propagating in HAZ - 50X and 100X

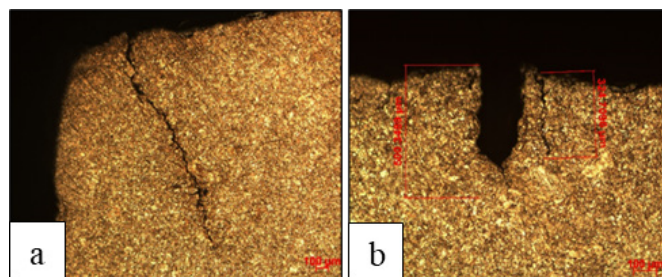
Secondary cracks beside the fracture surface were also observed (Figure 26)

Figure 26: Crack beside fracture surface on shell layer - 50X and 100X
