Failure Analysis and Field Repair of Urea reactor

The outer shell of a Multi-layered Urea reactor ruptured while the plant was in operation. The plant made an emergency shutdown, samples were collected, and an investigation carried out to establish the root cause of the failure. The paper explains the detailed analysis performed, corrective action implemented, and a health assessment for the equipment's safe working. The paper also includes references to similar failures in old multi-layered urea reactors subsequently and the mitigation plans to avoid such failures.

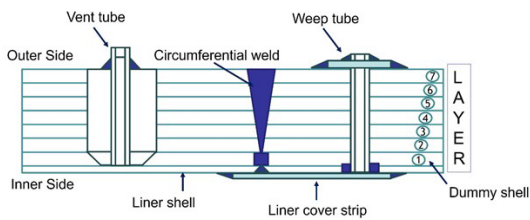
Figure 2: Constructional features of multi-layer

The design and construction features of the subject Urea reactor is shown in Table 1 and a diagram of features in a multi-layer urea reactor is shown in Figure 2.
